SPECIAL AIRWORTHINESS INFORMATION BULLETIN

CE-05-85
September 20, 2005

Technical Note

- Subject** : Lower mounting of the rudder
- Effectivity** : DG-100, DG-200, DG-300, DG-400, all models and all ser.no.'s
DG-500, DG-500M all models up to 5E23
DG-600, DG-600M all models and all ser.no.'s.

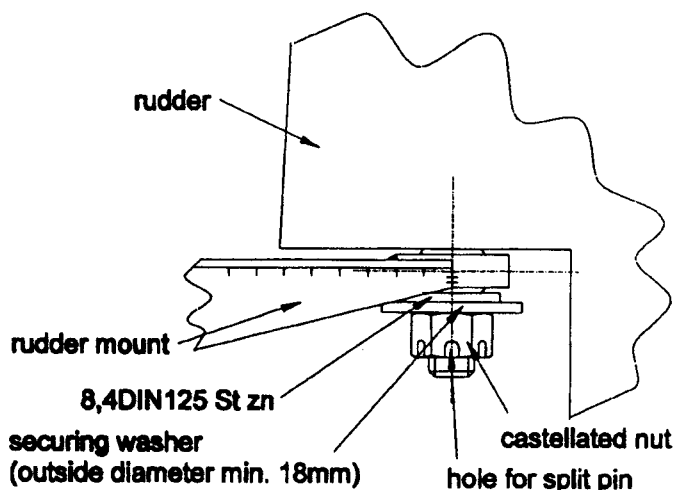
- Reason** : On a DG-100 the universal bearing of the lower rudder mounting slipped out of the bearing support and the rudder fell out.
As the design is similar on all DG-types this kind of failure may occur on all DG's.
On later models this connection was secured by an extra securing washer.
Such a washer must be retrofitted to all DG-types with this TN.

- Instructions**
1. Check if the outer bearing ring is correctly in place in the rudder mounting, the ring should not be visible.
 2. If the bearing is out of place the rudder mounting must be removed and the bearing must be secured by peening with a chisel or the complete rudder mounting must be exchanged. In addition execute instruction 3 at the same time.

3. Check if a securing washer (min. outside diameter 18mm, 0.71 inch) is installed according to the sketch.
 - a) If yes: The execution of this TN can be entered in the aircraft logs by a licensed inspector without further work to be done.

- b) If no: Remove the castellated nut, install the washer 8.4 DIN9021 and reinstall the nut.
 1. Check if the washer is interfering with the rudder mount. If yes, use a washer 6,4DIN9021 St zn instead, enlarge the 6mm hole to 8mm to enable installation.

2. Check if the split pin can be installed. If yes, secure with a new split pin 2x20 DIN94 zn.

If this is not possible, mark the position for a new hole and remove the rudder.
Drill a new hole (diameter 2mm, .08 inch) 90° to the existing hole.
Reinstall the rudder, use new split pins.
